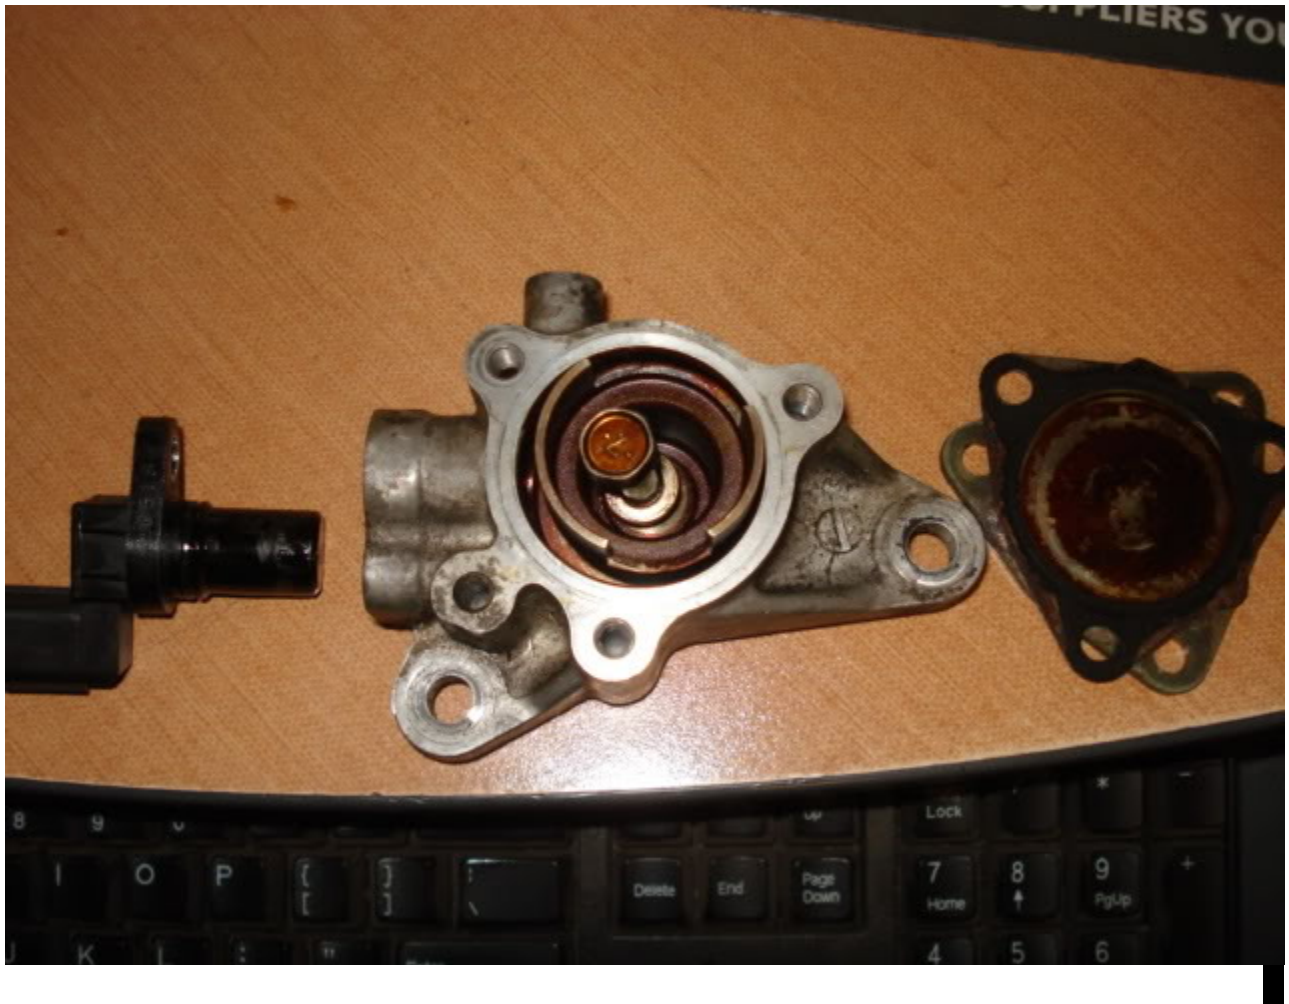
The [gasket](#) on the front of the housing (3 bolt) is part number MD329503. If it's not too severely damaged/worn, you could always try a *THIN* coat of RTV to patch it in the meanwhile.

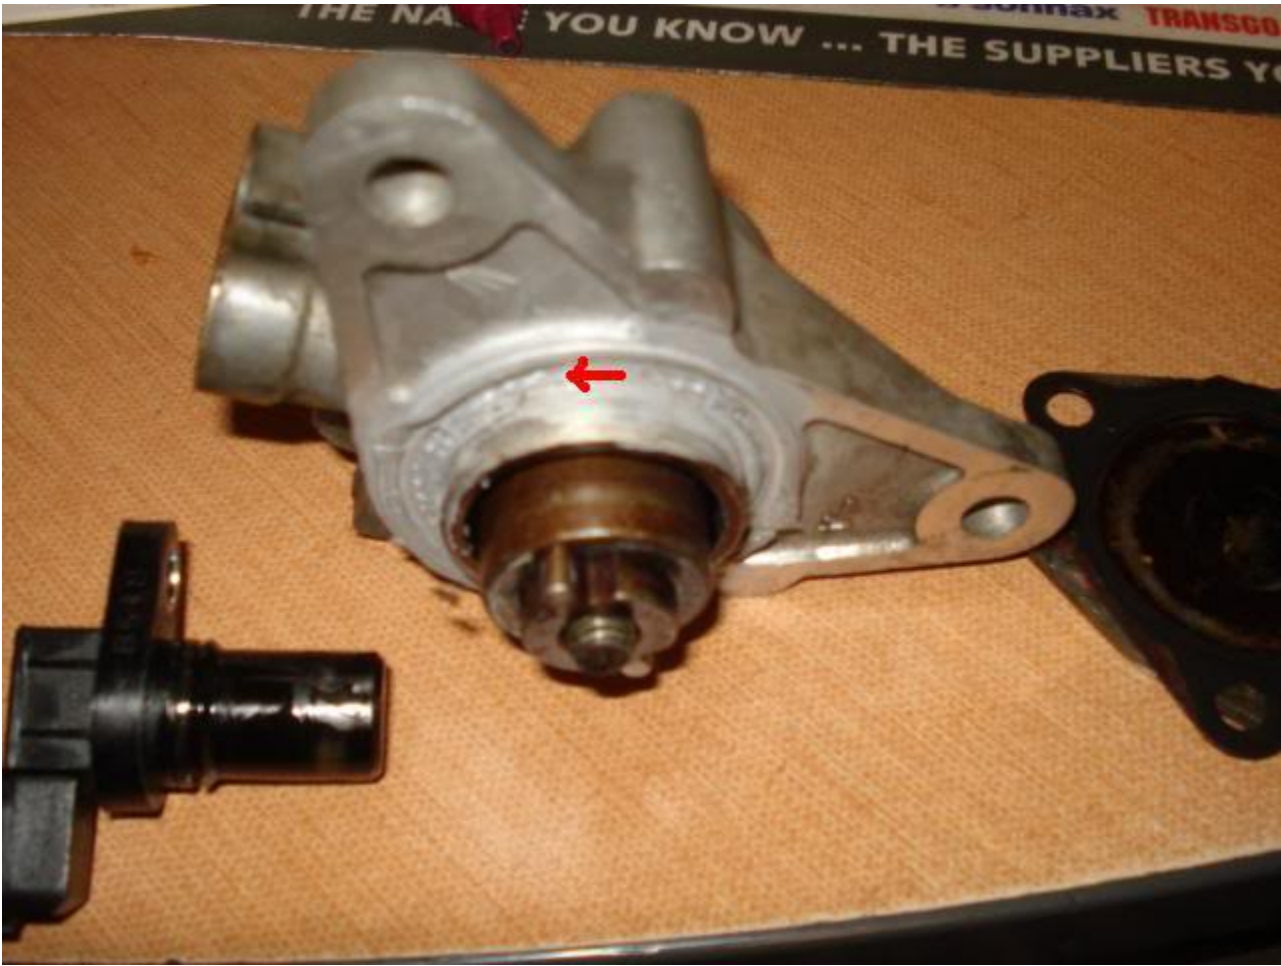
I grabbed a used one that was sitting back in the parts bin (please excuse the child-like use of [Paint](#)). You can see in the 2nd picture (arrow) where the groove is that you need to RTV.

You already have the other seal for the CAS itself (MD622021), so the only other seal is on the back side where it seals to the head. If you're getting leakage out of the front cover, I would probably not only fix the 3-bolt cover gasket, but reseal the RTV on the rear where it sits against the head.

Make sure that you [clean](#) off both surfaces (head and CAS) to remove the old RTV and oil.
